TELL ASMAR, KHAFAJE AND KHORSABAD

SECOND PRELIMINARY REPORT
OF THE
IRAQ EXPEDITION

By
HENRI FRANKFORT

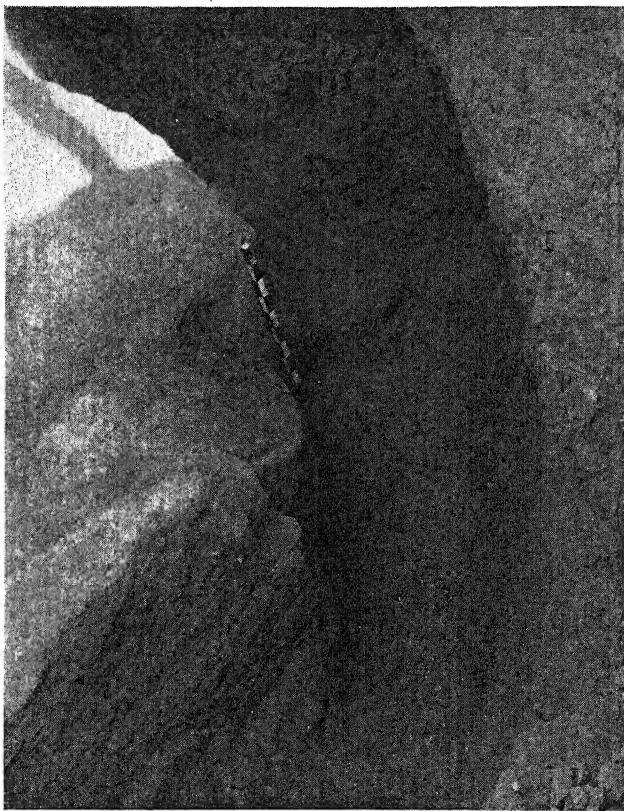
FIG. 6.—Corner of the retaining wall around the Gimilsin temple

the main temple wall was a low retaining wall with corners of an unusual shape (Fig. 6). This was evidently a later addition, and it helped to preserve the lower part of the ornamented panels on the towers. The retaining wall can be traced on the northern, eastern, and southern sides; but just after it turns at the southwest corner it is bonded

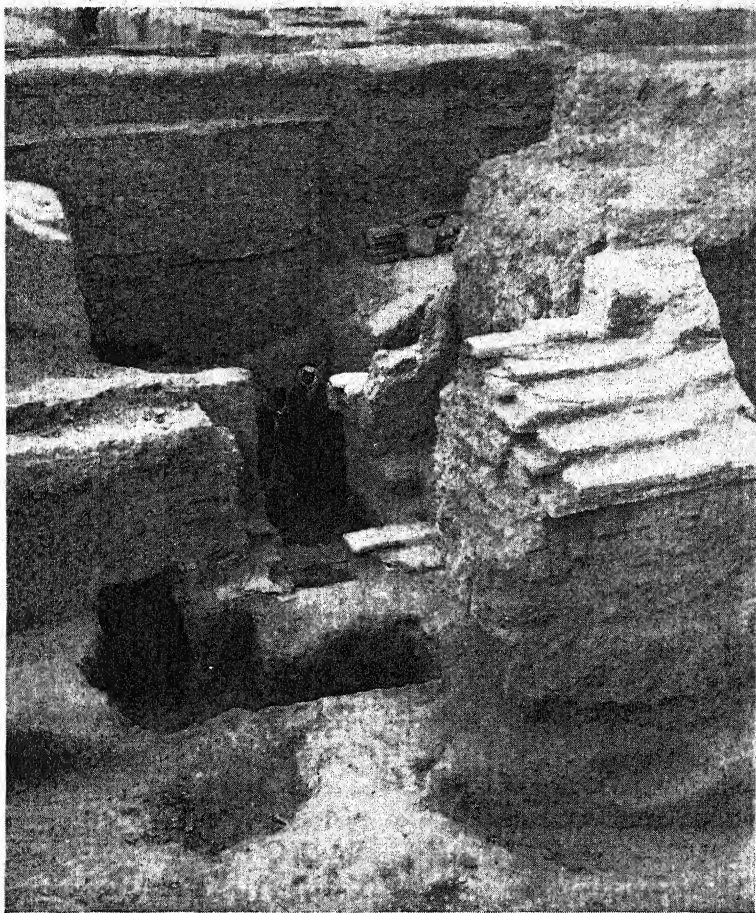
FIG. 10.—The main entrance to the palace, showing from top to bottom the two steps of Ibalpel (baked bricks removed); the five steps of Ibiq-Adad I (still in position); the white pivot stone of an intermediate layer (farther back); Bilalama's steps (partly removed); and, lower down, one step of the first palace.

lel case being provided by the palace entrance, which remained in the same spot for over three centuries (Fig. 10).

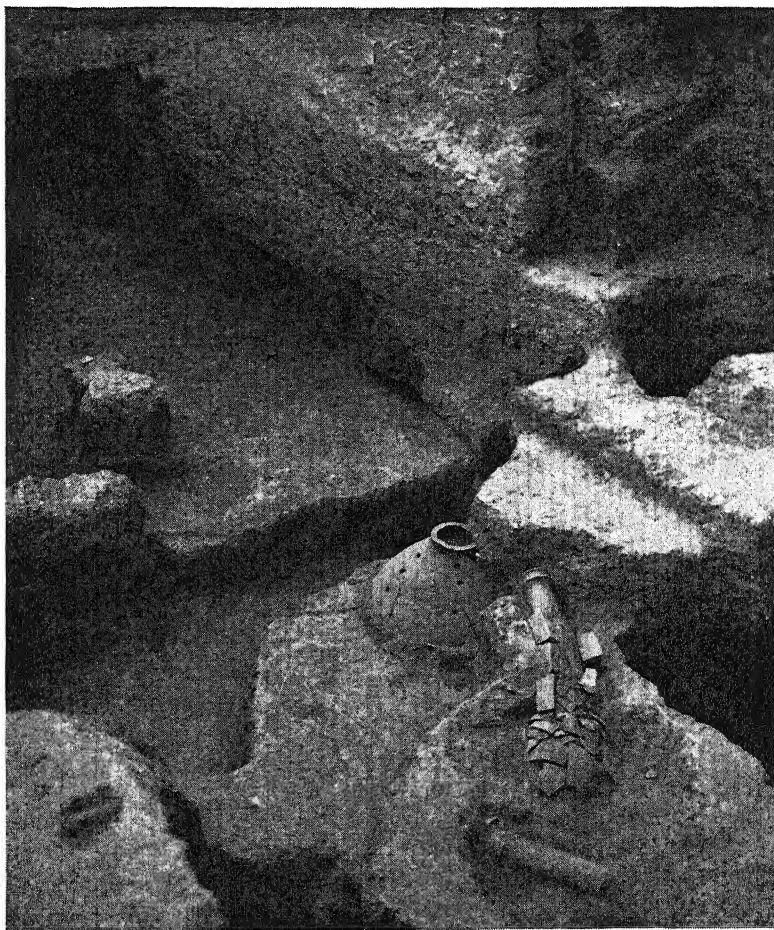
FIG. 14.—Pottery drains in the pavement in front of the niche in the cella of the Gimilsin temple. The hole dug in the platform was made by ancient robbers digging for the foundation deposit.

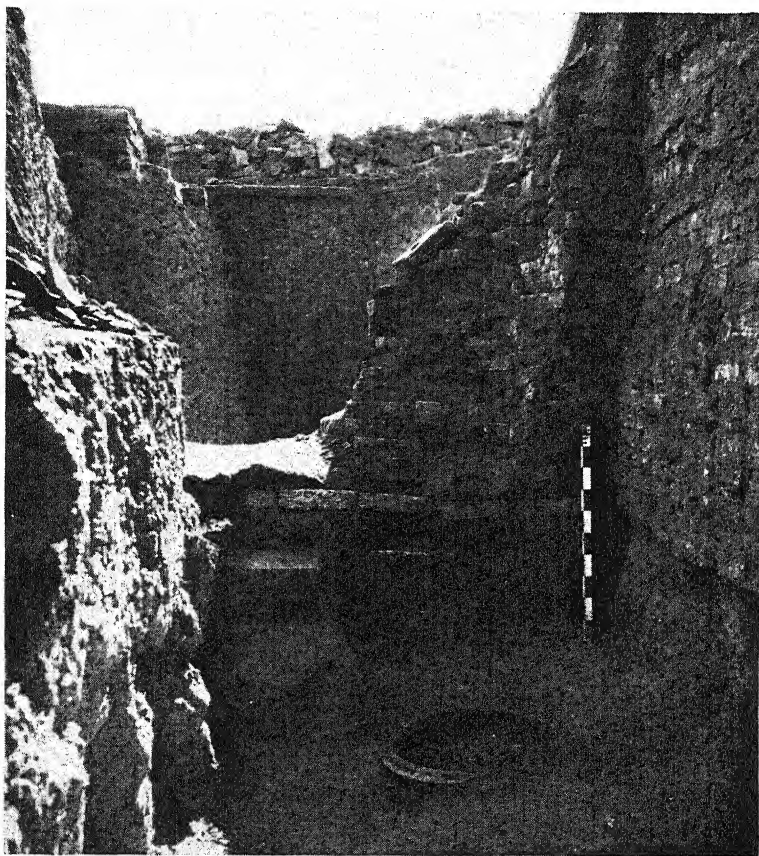
FIG. 20.—Walls of Bilalama and Urninmar

The room at the southwest corner of the palace courtyard is shown in Figure 20.¹⁶ The baked brick foundation at the back of the room

belongs to Urninmar's building. A white line 20 cm. below its base is formed by a decayed mat upon which a wall of Bilalama's palace had been built. To the left of this line a baked paving-brick shows the actual floor level in Bilalama's time. Here then the Bilalama wall was preserved to a height of only 20 cm. It bears traces of the conflagration, similar to those found all through this layer. At the right of the photograph, level with the Urninmar foundation, walls of unbaked bricks are seen resting on rubbish which filled the Bilalama palace at this spot. All this had to be removed before we could trace the earlier buildings.
